**CWA COMPLIANCE EVALUATION INSPECTION REPORT
U.S. ENVIRONMENTAL PROTECTION AGENCY, REGION 5**

Purpose: Compliance Evaluation Inspection

Facility: FOIA Ex 6 Enterprises, LLC

Date of Inspection: September 19-20, 2018

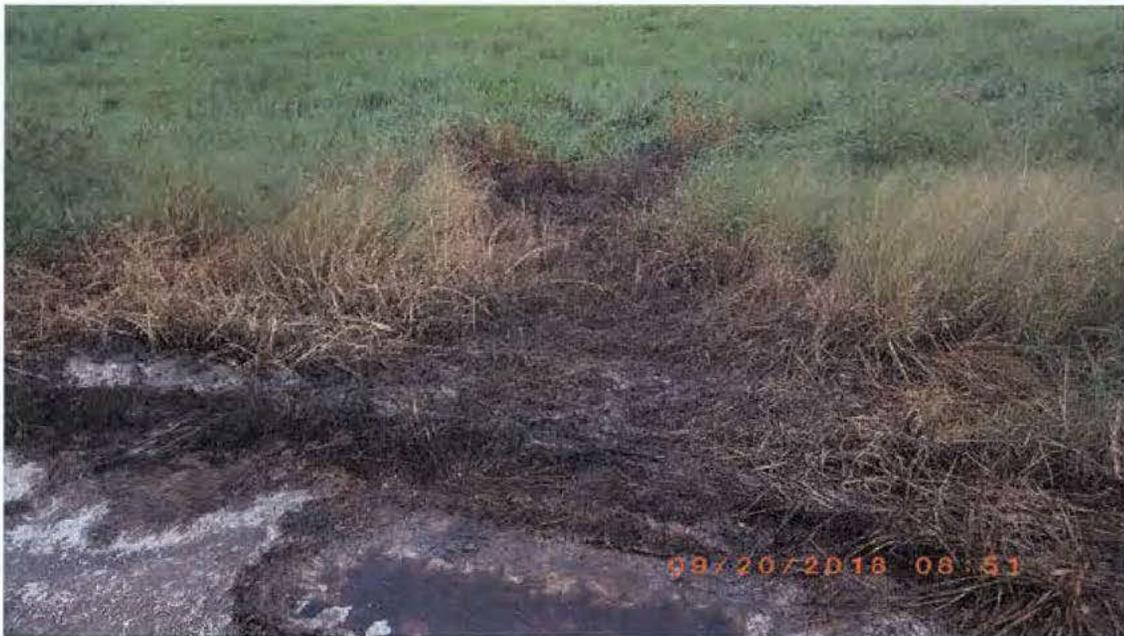
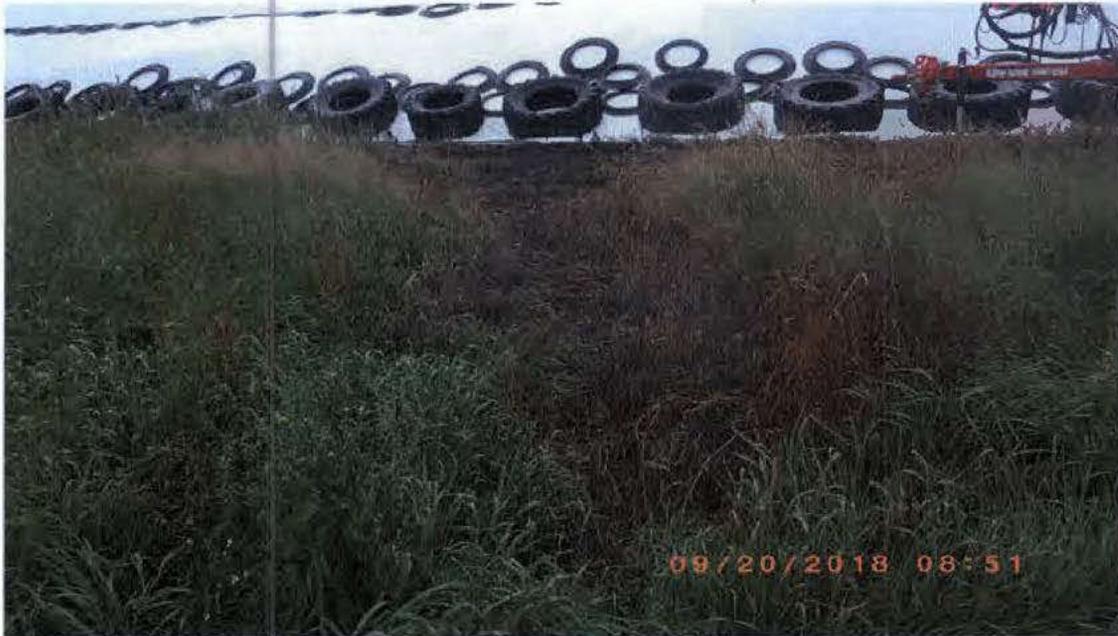
Description: The wastewater had killed vegetation at the point where it flowed off the concrete and dead vegetation was observed approximately 10 feet into the grassed area.

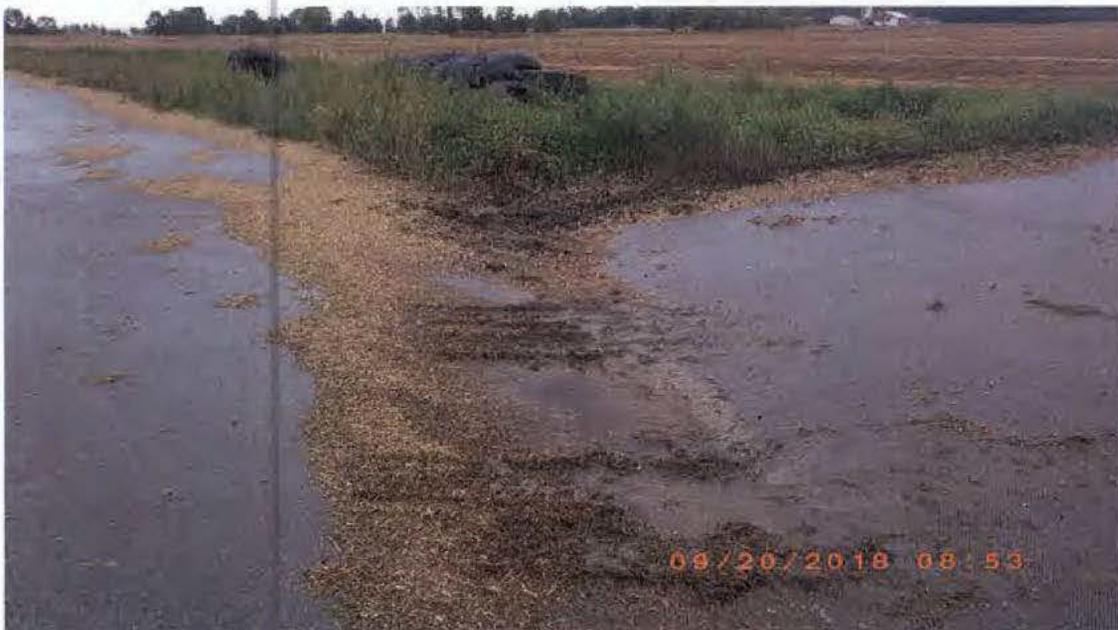
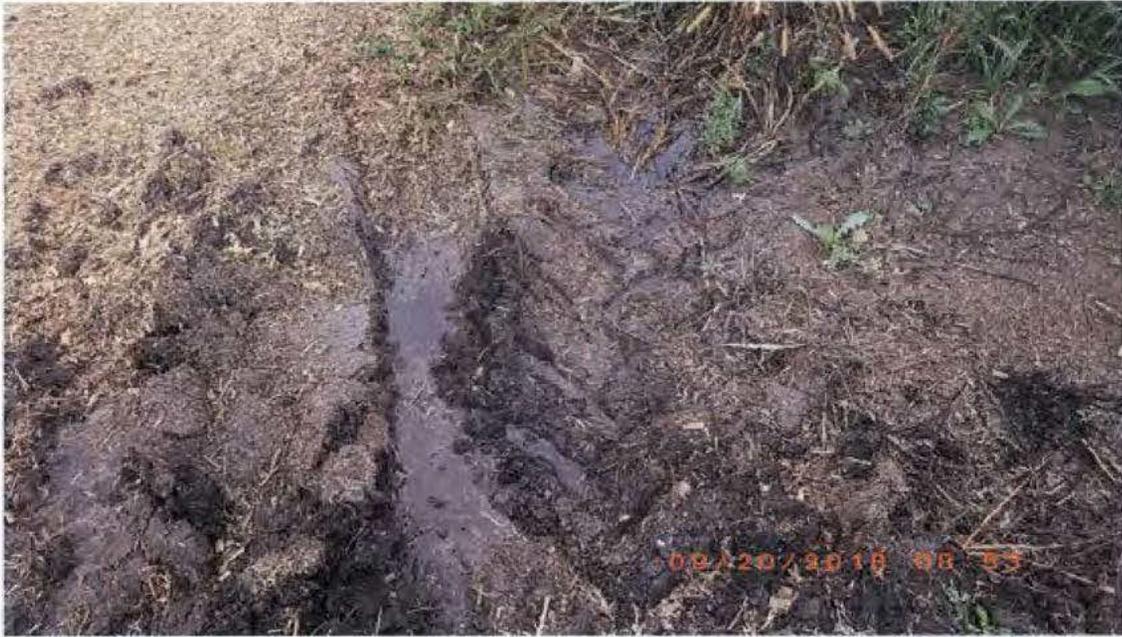
Description: Feed solids were observed on the ground in an area that could drain southeast off the feed storage area.

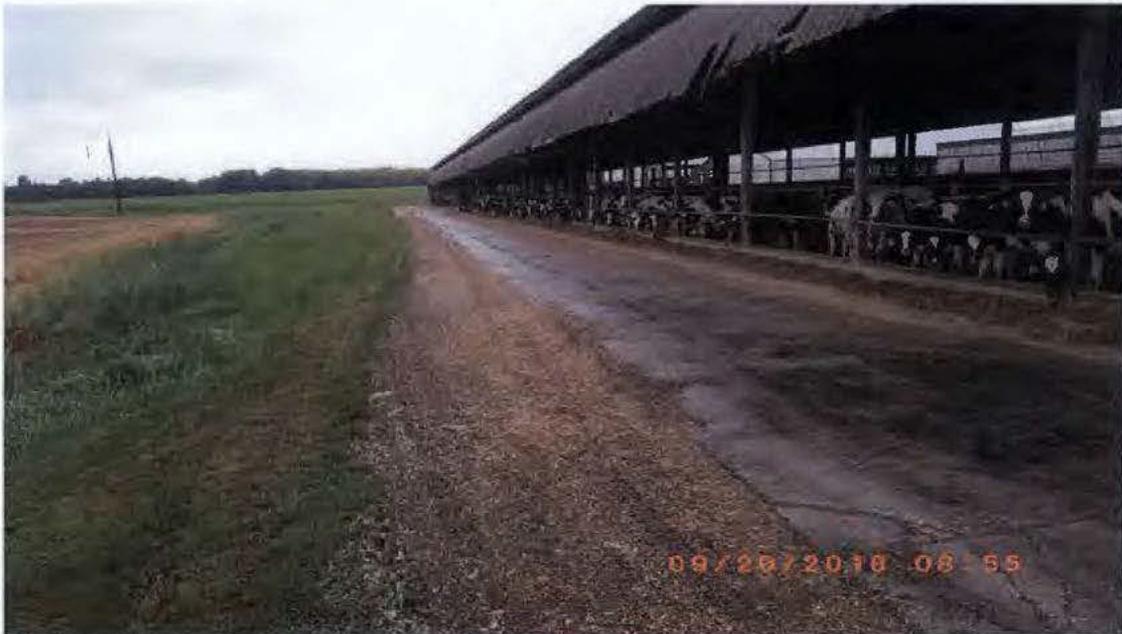
67: RIMG0462

Description: Feed solids were observed along the southern end of the barn on the south end of the site.

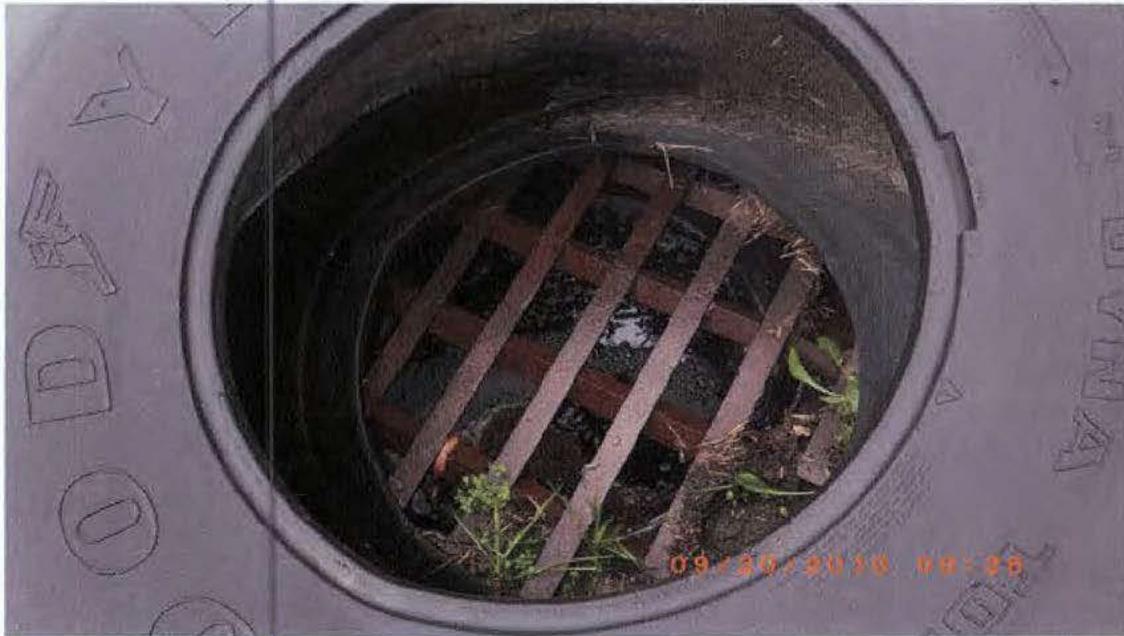
68: RIMG0463

Description: Water was draining into the inlet for the old feed storage area.

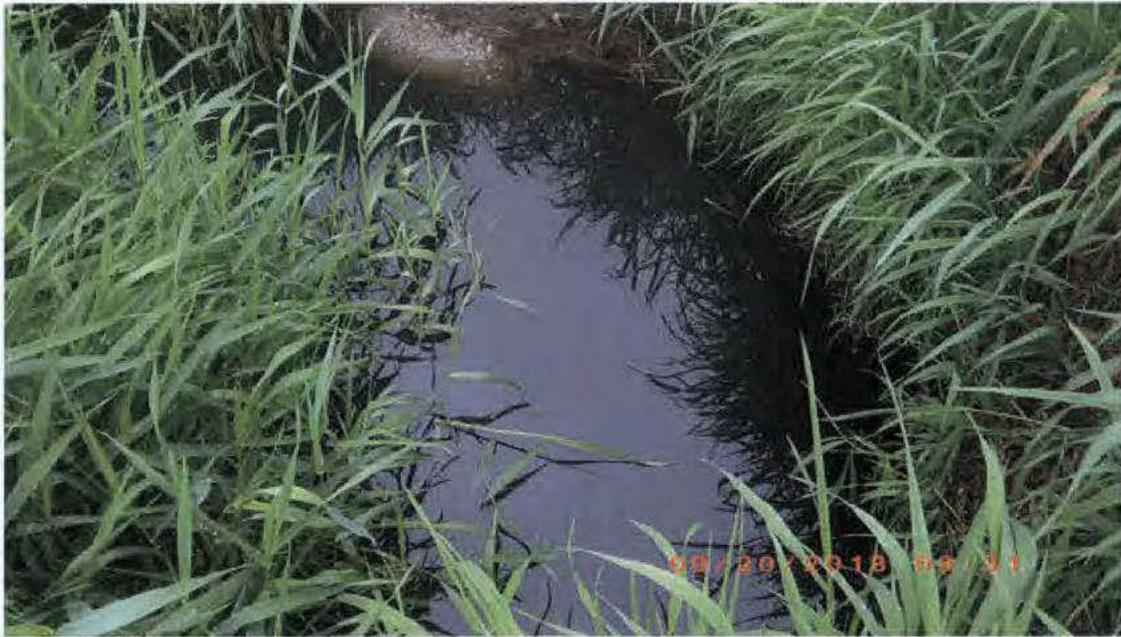
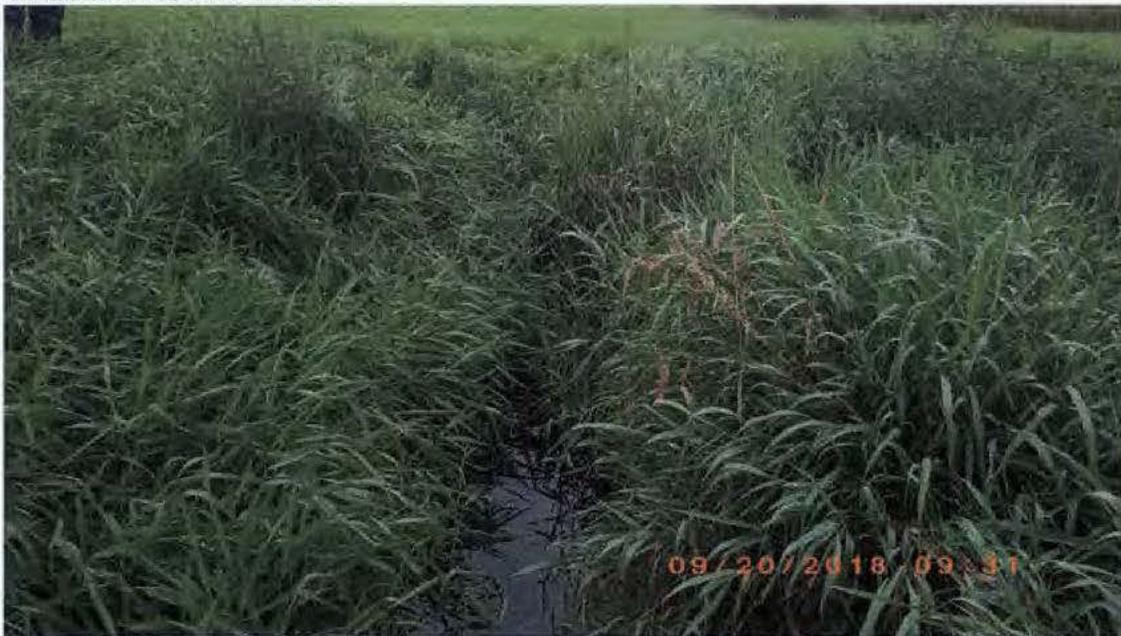
- At the Main Facility, at Field Point A, dark ponded water was observed in the VTA. A significant storm event could move this water through the VTA and may eventually reach a navigable water.

Description: The entrance into the vegetated treatment area (VTA) had ponded water that was dark in color. The water was located at the pipe outlet and was not observed flowing through the VTA.

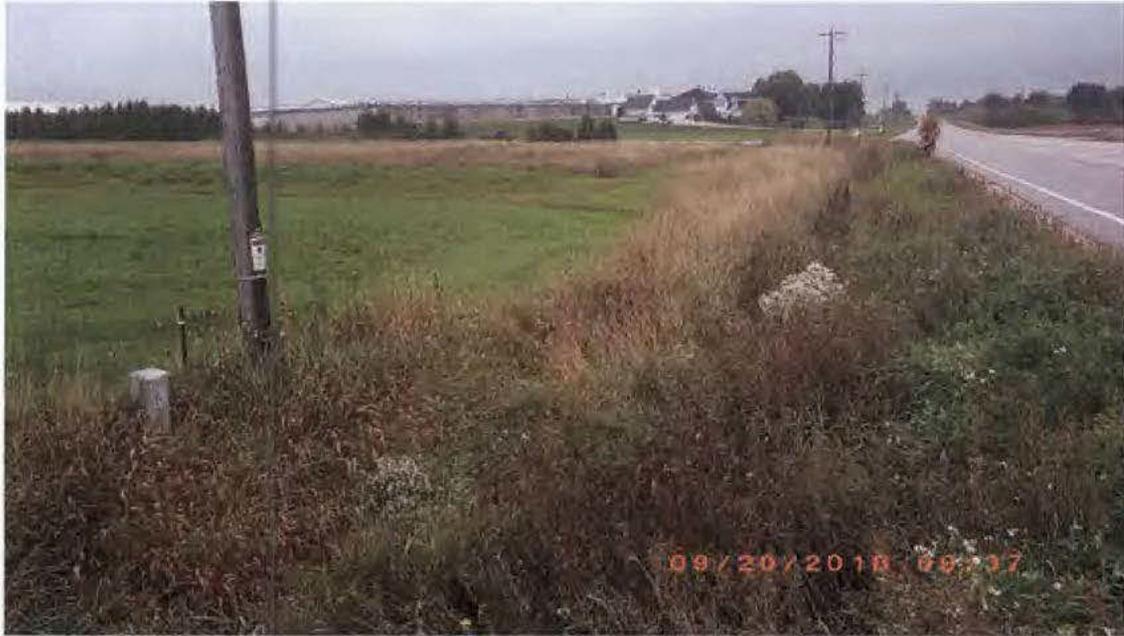
72: RIMG0467

Description: At the east end of the VTA water would flow into a ditch that drains south and then east under the road. No water was present in the VTA (except at the entrance), in the ditch, or entering the culvert.

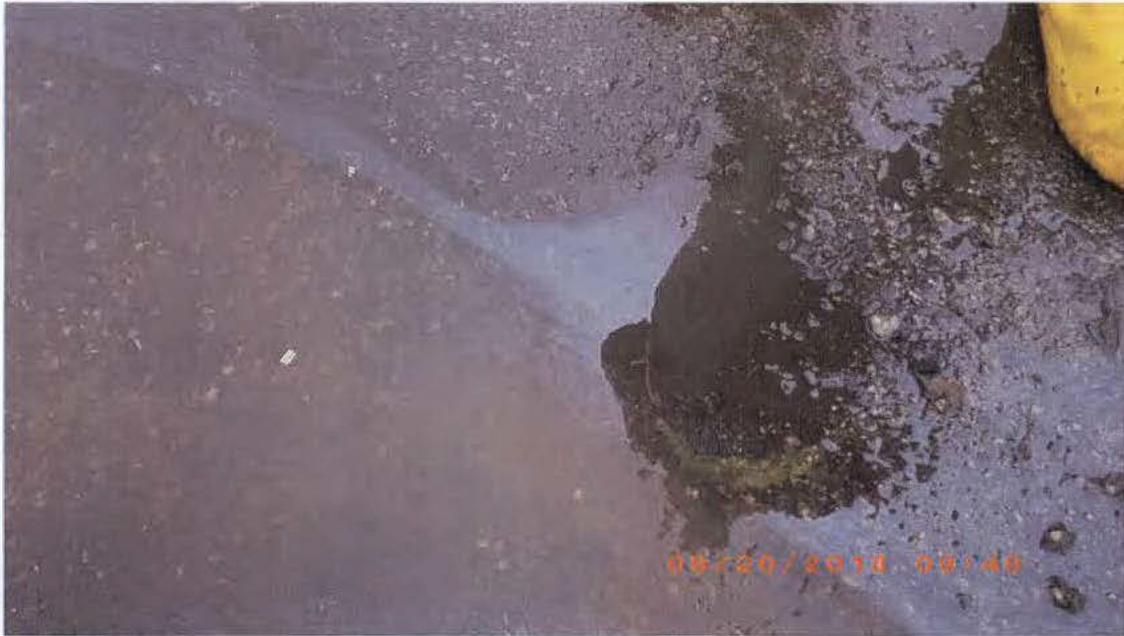
78: RIMG0473

Description: A small amount of sheen was observed on the water surface that drained to the storm water inlet.

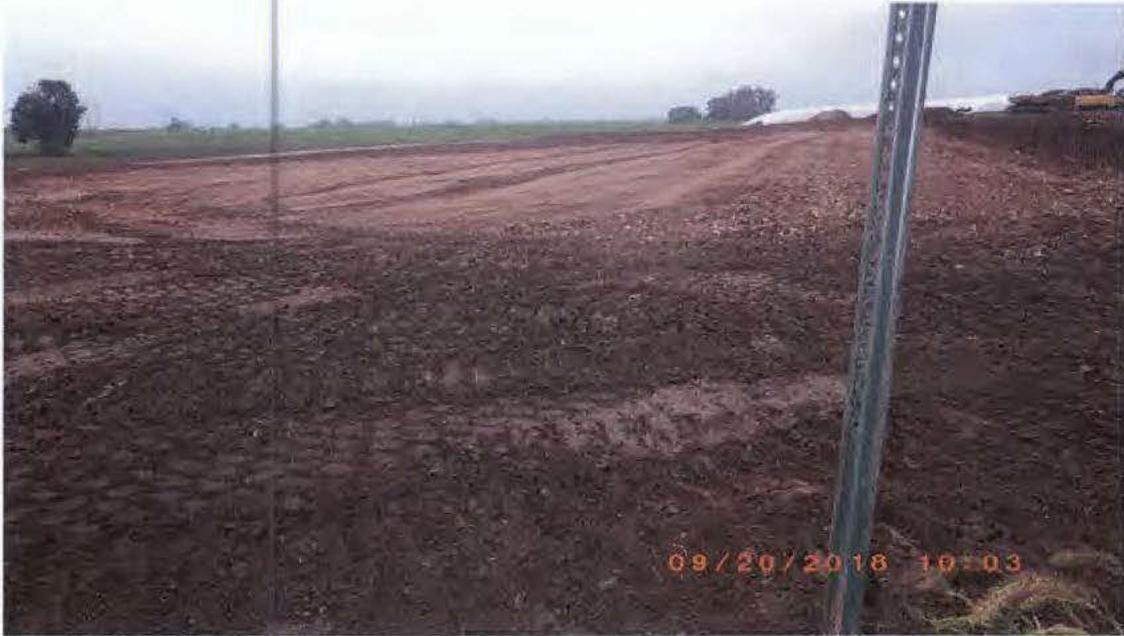
88: RIMG0483

Description: Earthmoving had started at the west end of the Main Facility.

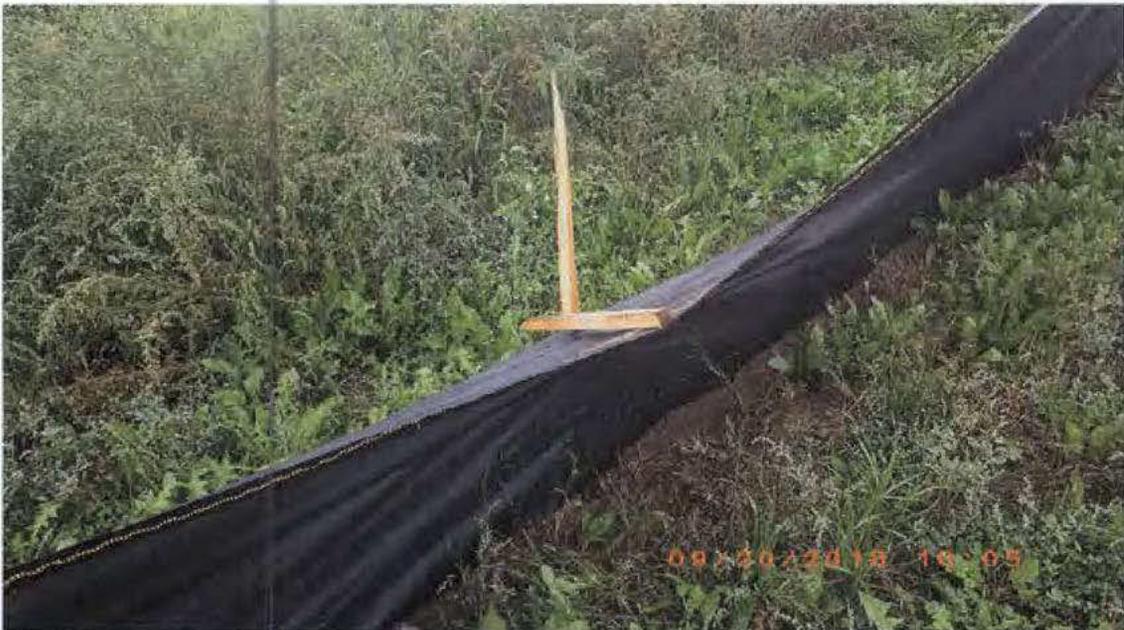
89: RIMG0484

Description: EPA observed a broken silt fence post.

According to Permit Condition 2.9.4 Maintenance of BMPs, "The permittee shall ensure that all BMPs are maintained and remain in effective operating condition during permit coverage and are protected from activities that would reduce their effectiveness."

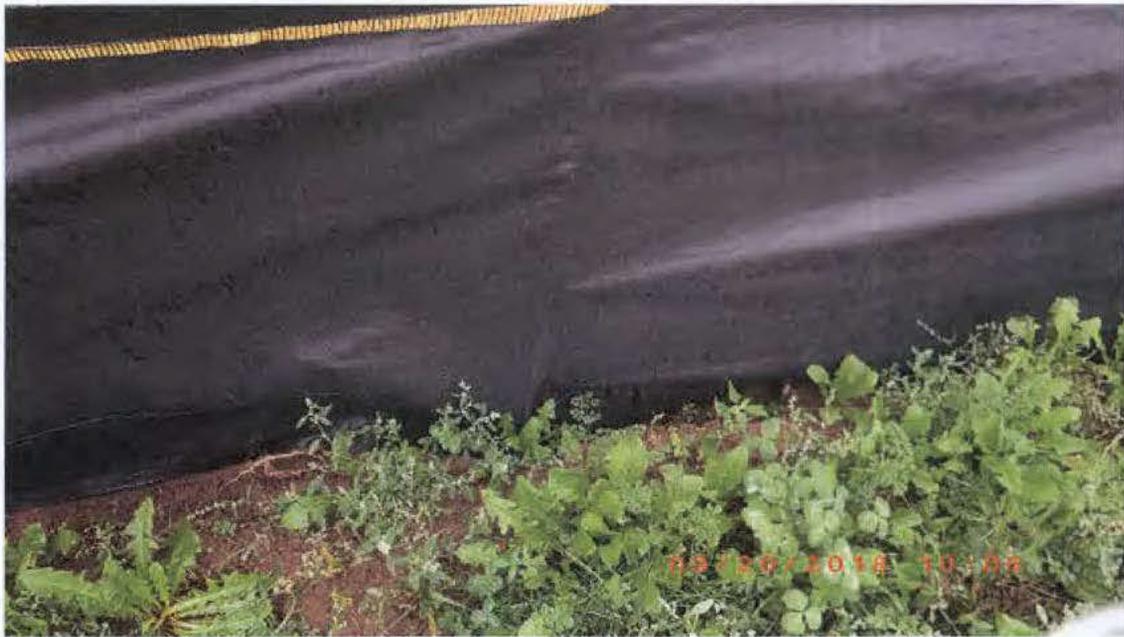
90: RIMG0485

Description: In many locations the bottom of the silt fence had not been anchored properly.

According to Permit Condition 2.9.3 Installation of BMPs, 2.9.3.1 By the time land disturbing construction activities in any given portion of the site begins, install and make operational any erosion or sediment control practices that prevent or treat discharges for the initial site clearing, grading, excavating, and other land disturbing construction activities."

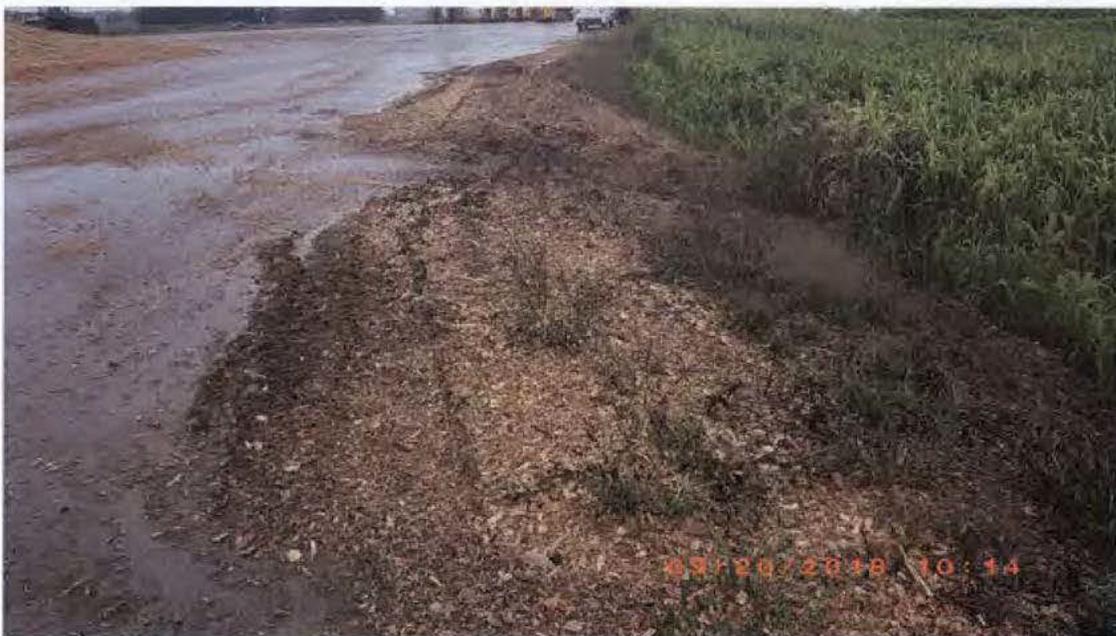
95: RIMG0490

Description: Feed solids were observed blown into the field on the north side of the feed storage area.

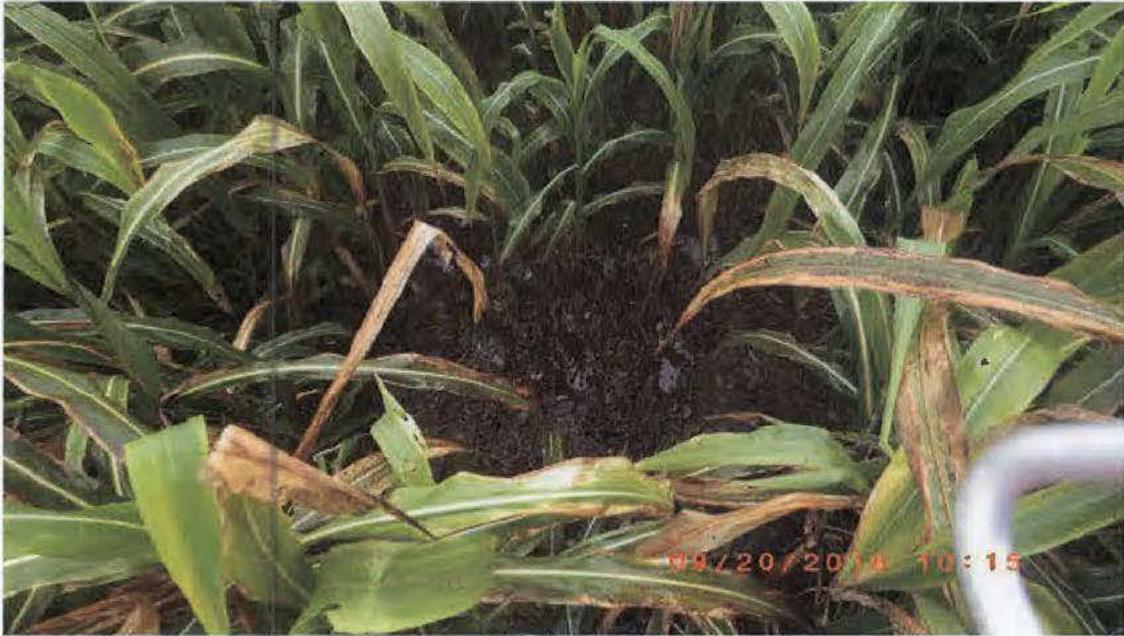
96: RIMG0491

Description: I observed some water in the field north of the feed storage area with a brownish color.

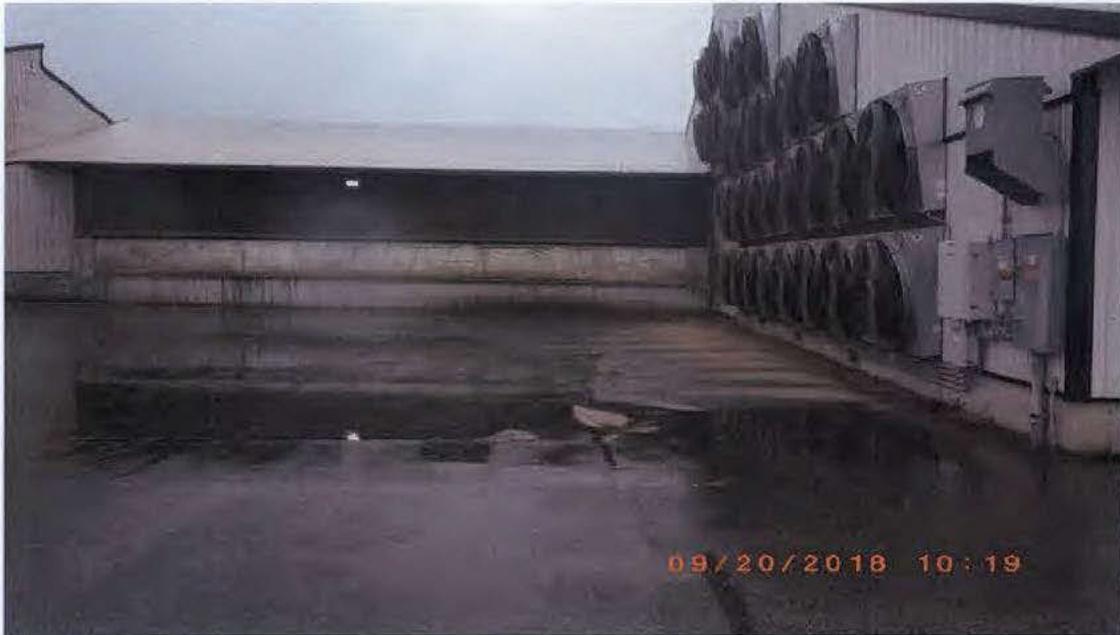
98: RIMG0493

Description: A small amount of blown dust was observed adjacent to the building fans. This area drains to a storm water inlet.

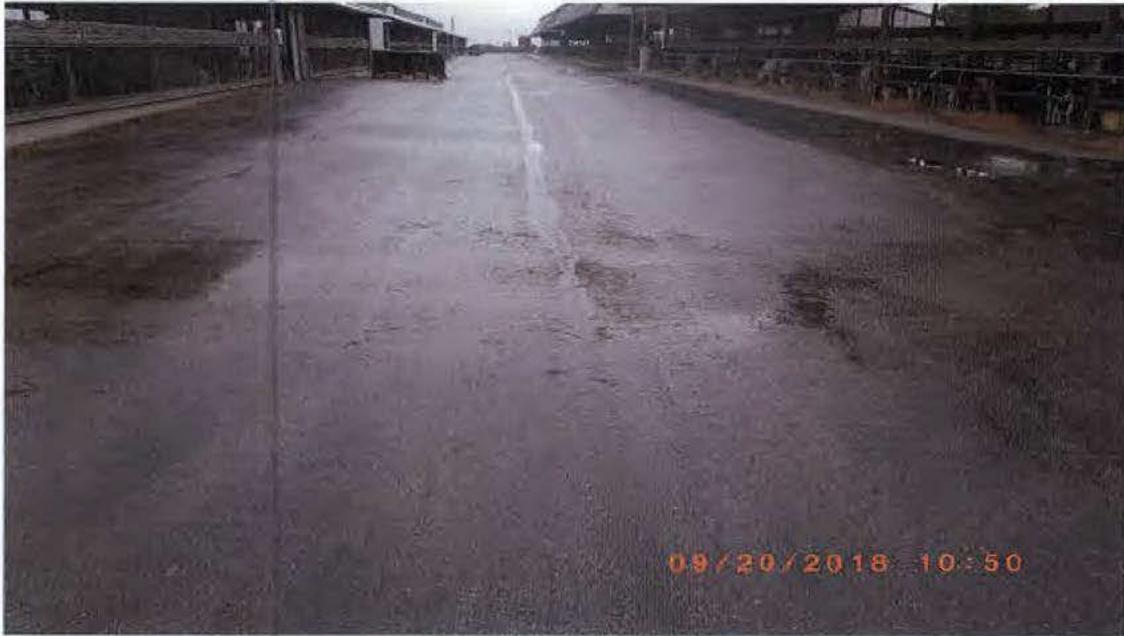
104: RIMG0499

Description: The storm water between the calf and heifer barns flowed from west to east.

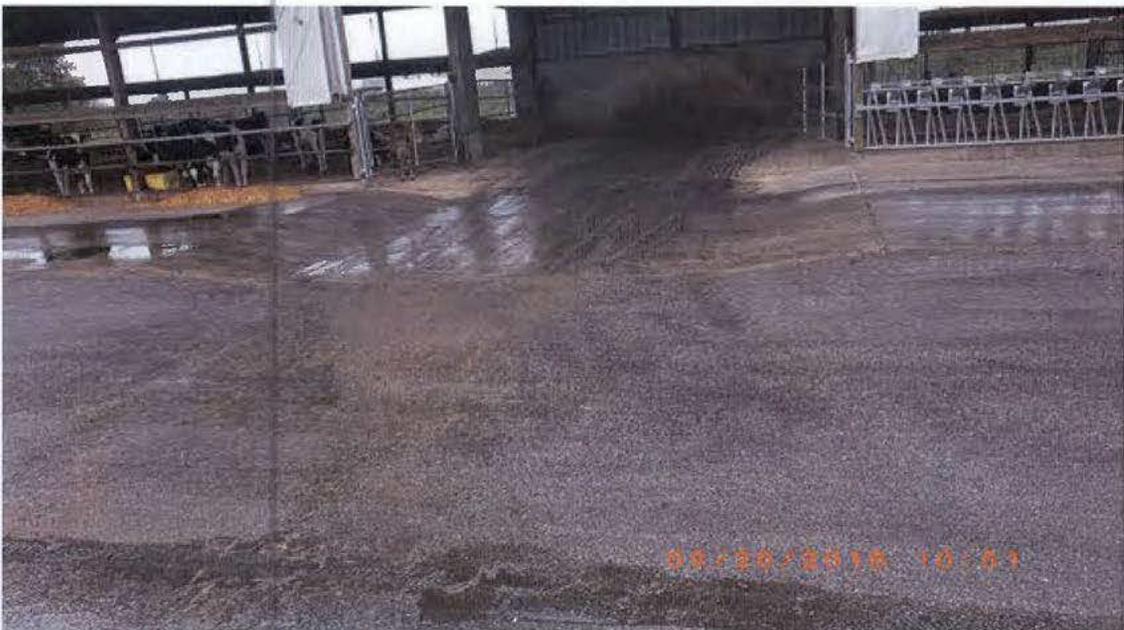
105: RIMG0500

Description: Track out of manure was observed at the heifer barn which would flow with storm water to the east.
